## THE STRUCTURAL AUDIT OF EXISTING SCHOOL BUILDING

RYAN INTERNATIONAL ACADEMY WAGHOLI PUNE

## STRUCTURAL AUDIT REPORT

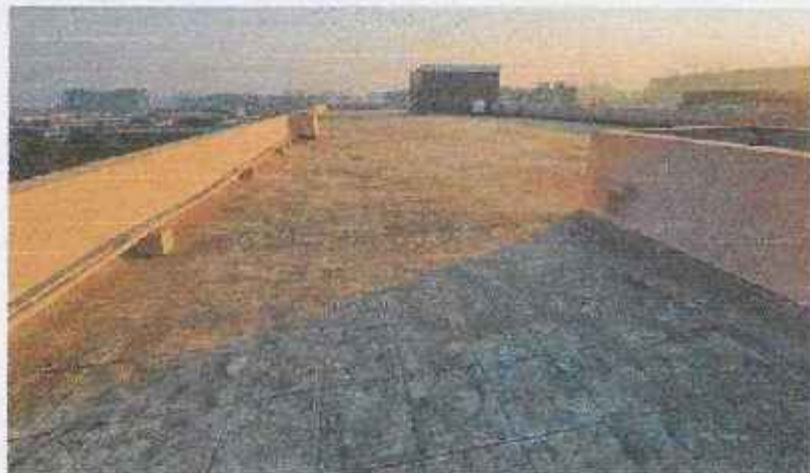
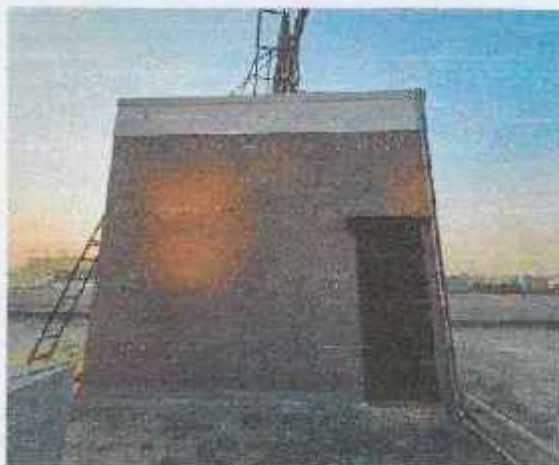
Terrace floor

- External plaster cracks at few places on terrace floor.
